# ACCELERATED WEATHERING TESTS OF SOLDERED AND TINNED SHEET COPPER

By Peter R. Kosting<sup>1</sup>

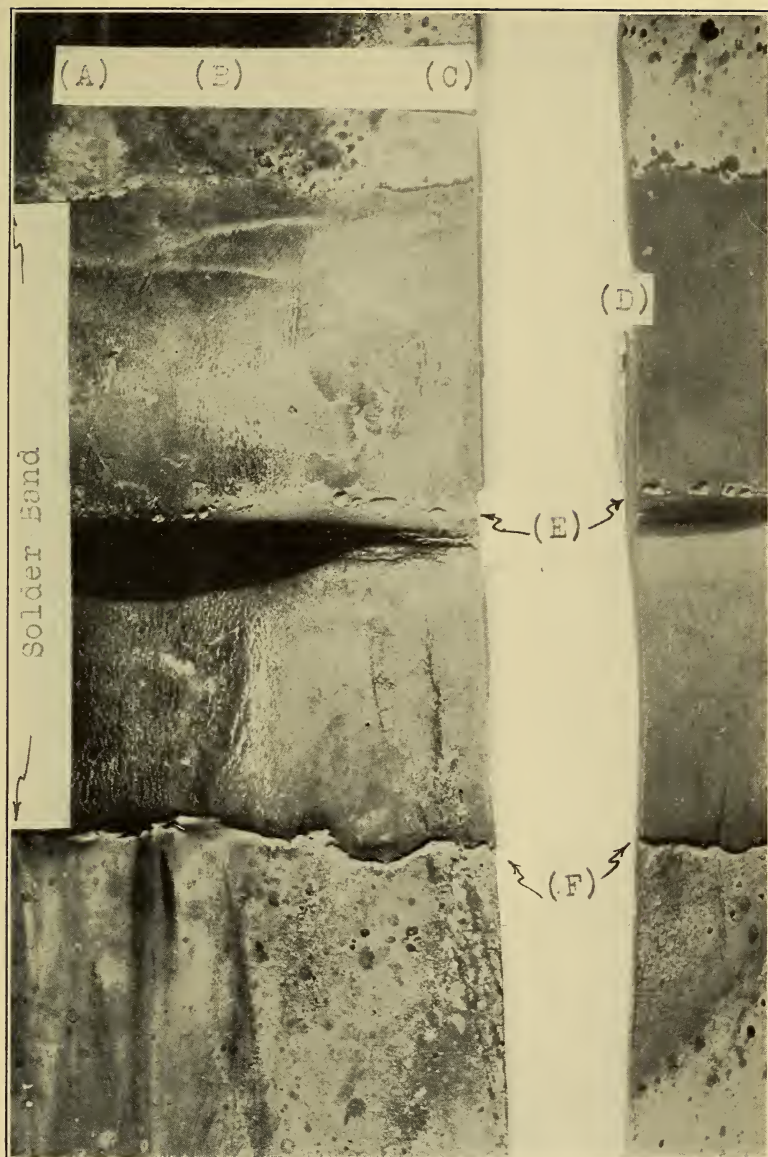
A typical case is illustrated by a sample of sheet copper which had been in service for 16 to 20 years as a valley (fig. 1) in the roof of a residence, and which was sent to the Bureau of Standards for examination. Marked furrowing was observed in the copper along the lower edge of the solder band at those portions not covered by the shingles. No localized corrosion of the copper had occurred along the upper edge, except in the areas where the flow of rain water was greatest. Pits extending through the solder into the copper had formed along the high ridge of the soldered lock seam. Evidence of included flux was obtained upon sectioning the seam. Cavity *D* was found to be filled with liquid, probably flux; likewise, the underside of the seam gave indications that flux had been left in place, although there was no evidence of any deep-seated corrosion having occurred.

FIGURE 1.—Seam corrosion on soldered copper valley.  $\times 2$

A, Etched copper where flow of rain water was greatest; B, tarnished copper; C, patina covered copper where flow of rain water was least; D, hole of seam in which flux was trapped; E, pits extending through solder at high ridge of seam; F, furrow at copper-solder junction.

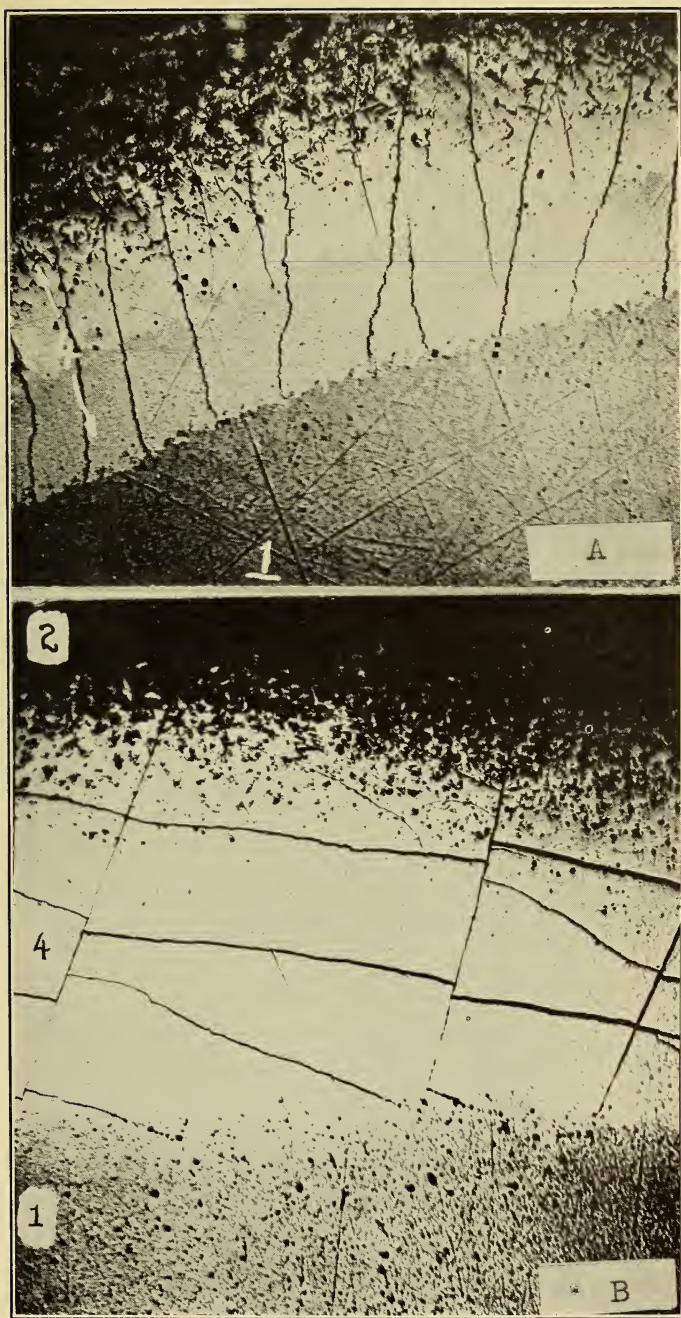
FIGURE 3.—Oblique sections of heat treated electroplated sheet copper showing cracks in coating.  $\times 100$

A, Heated to  $350^{\circ}\text{C}$ .; B, heated to  $500^{\circ}\text{C}$ . 1, Sheet copper base; 2, unchanged tin; 4, copper-tin alloys. Both unetched.

The microstructure of the coatings on heat-treated electrotinned copper was rather complex. Electrotinned copper had but one phase present in the coating—the tin. Upon heating to  $350^{\circ}$  and  $500^{\circ}$  C., the copper and tin alloyed, copper dissolving quite rapidly in the tin. The alloy layers were brittle and slight bending caused them to crack, as shown in Figure 3. Many of these cracks extended through the alloy layer only. During polishing a slight relief effect was sometimes obtained, as shown in Figure 3(a), thus revealing the complex nature of the coating.

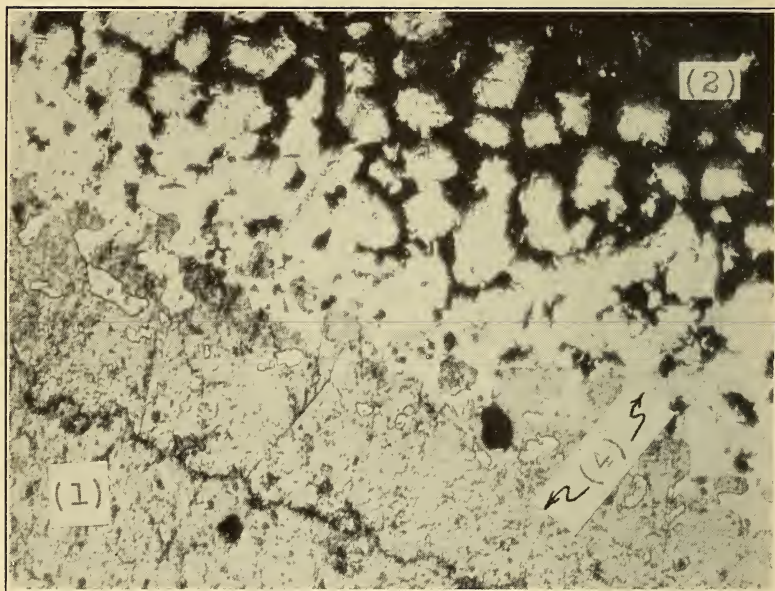
FIGURE 4.—*Oblique section of electroplated sheet copper heated to 350° C. for three hours.  $\times 500$*

Etchant: Nitric acid. 1, Sheet copper base; 2, unchanged tin; 4, copper-tin alloys.

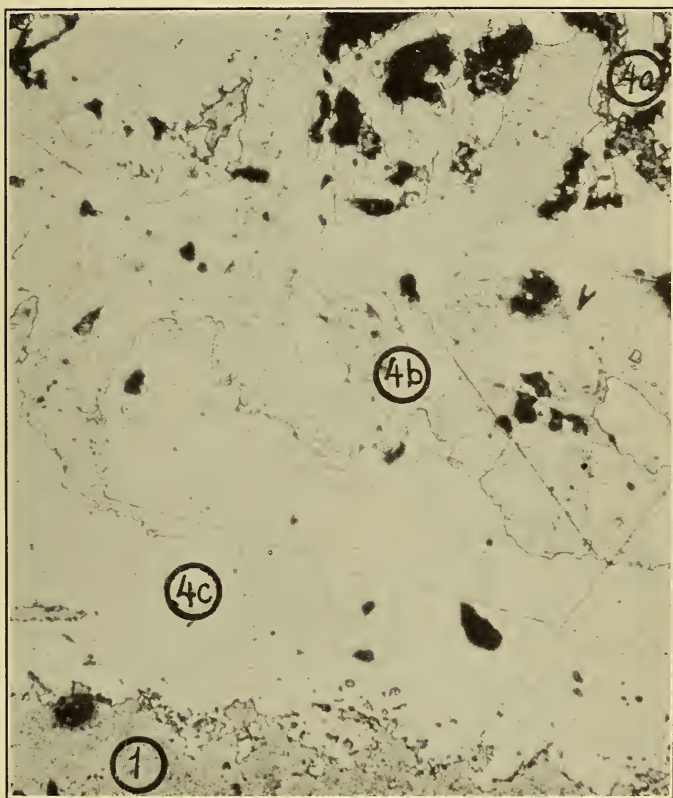
By heating to  $500^{\circ}$  C. another phase was formed which tarnished brownish on etching. This phase and the dove gray and brilliant white phases noted above are to be seen in Figure 5. In one place only, not shown, was the needlelike structure with a brilliant white fringe found to have a definitely blue color, characteristic of the  $\eta$  phase. It is assumed that the brownish phase is  $\delta$ , the brilliant white  $\epsilon'$  and the dove gray  $\eta$ .

FIGURE 5.—Oblique section of electroplated sheet copper heated to 500° C. for 3 hours.  $\times 200$

Etchant: Concentrated nitric acid. 1, Sheet copper base; 4a, brilliant white  $\epsilon'$  phase; 4b, bluish  $\eta$  phase; 4c, brownish  $\delta$  phase.

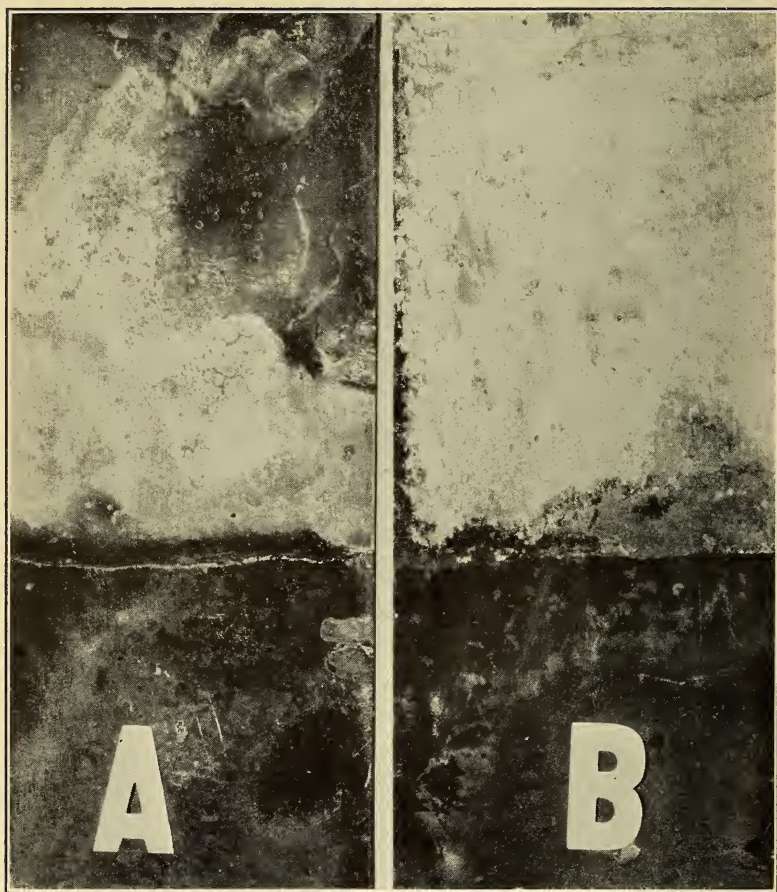
The physical appearance of the specimens after corrosion is shown in Figures 7 to 10. Figure 9 is a magnified view of the furrowing which is especially in evidence in the A specimen; the B specimen shows, on the other hand, very slight attack.

FIGURE 7.—*Seam corrosion after 100 hours accelerated weathering at 50° C.  $\times 0.7$*

The surface has been scrubbed with bristle brush and water. A, Soldered at 270° C. and heated to 500° C.; B, soldered at 270° C. Lower half is copper, upper half is solder covered

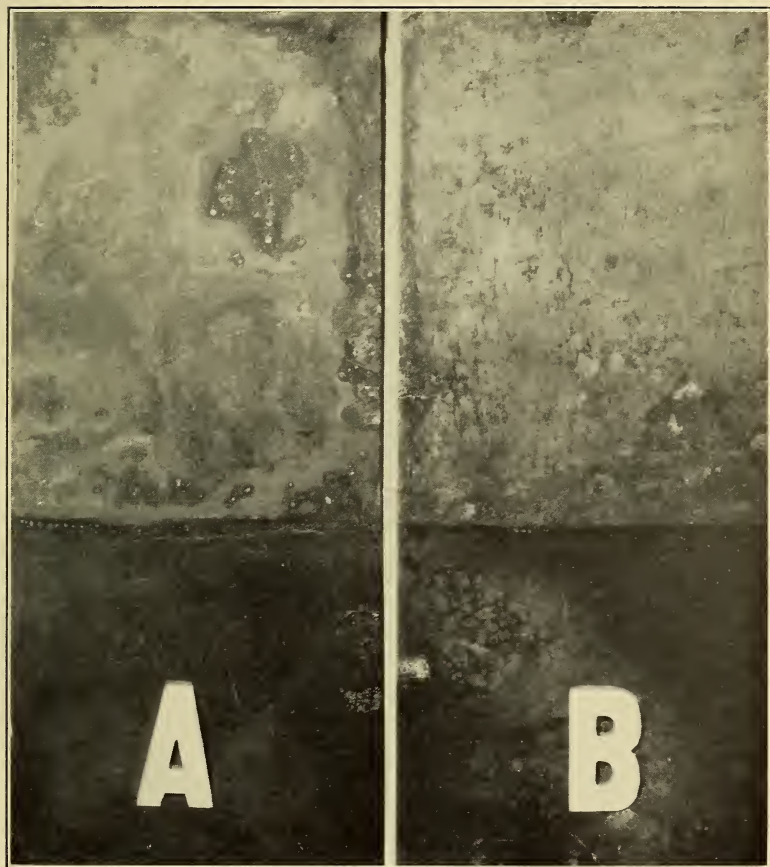
FIGURE 8.—Same as *Figure 7*, but after 200 hours accelerated weathering at 50° C.  $\times 0.7$

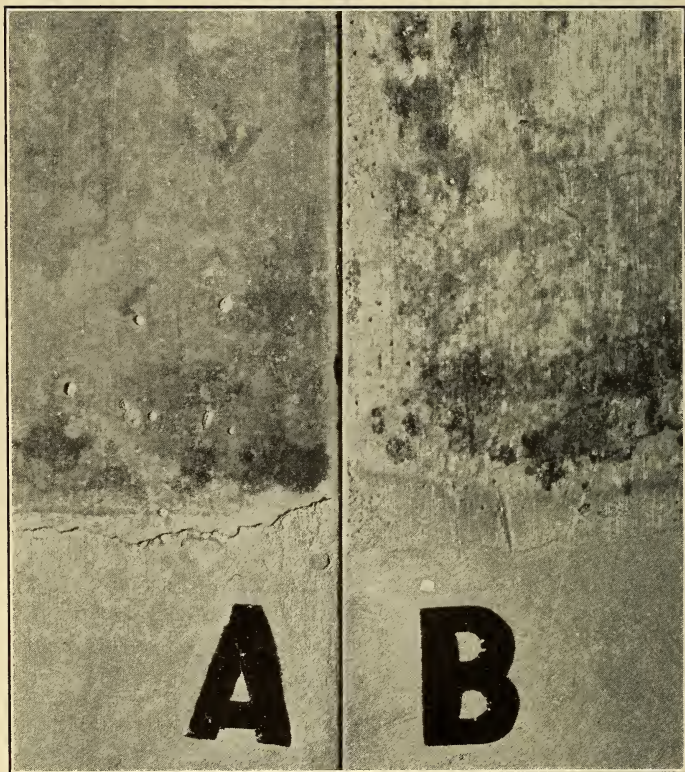
FIGURE 9.—Same as Figure 8, but after pickling.  $\times 3.7$

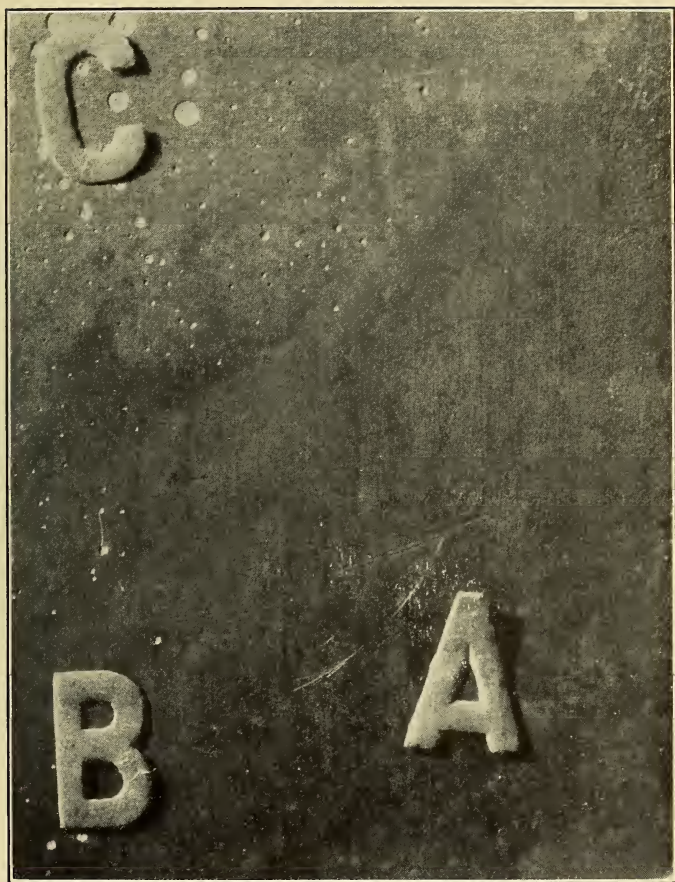
FIGURE 10.—*Phases on acceleratedly weathered soldered copper*  
A, Dull gray with no pits; B, blue gray with a few pits; C, white gray with many pits.

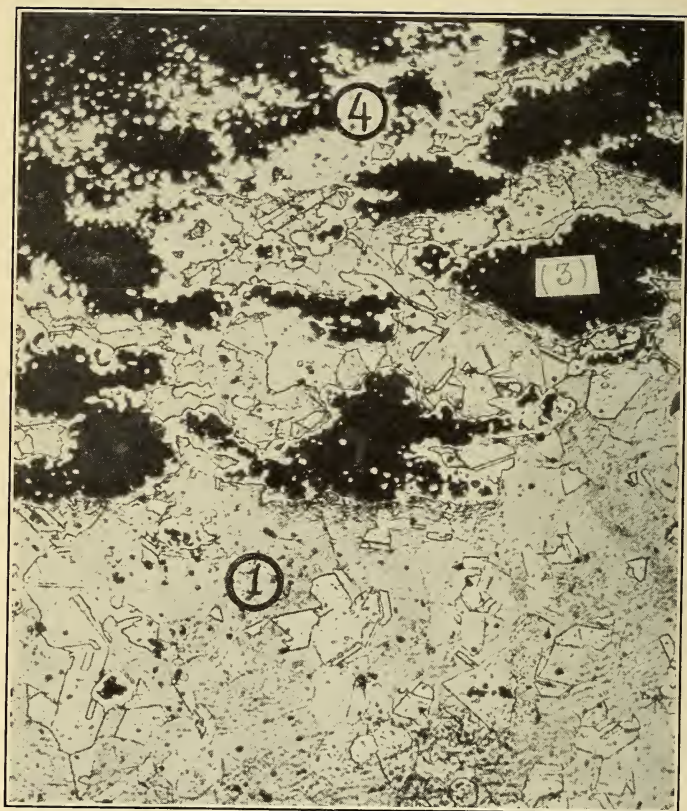
FIGURE 11.—*Oblique section of sheet copper soldered at 270° C.*  
× 500  
Etchant:  $\text{NH}_4\text{OH} + \text{H}_2\text{O}_2$ . 1, Sheet copper base; 3, unchanged solder; 4,  $\epsilon'$  phase.

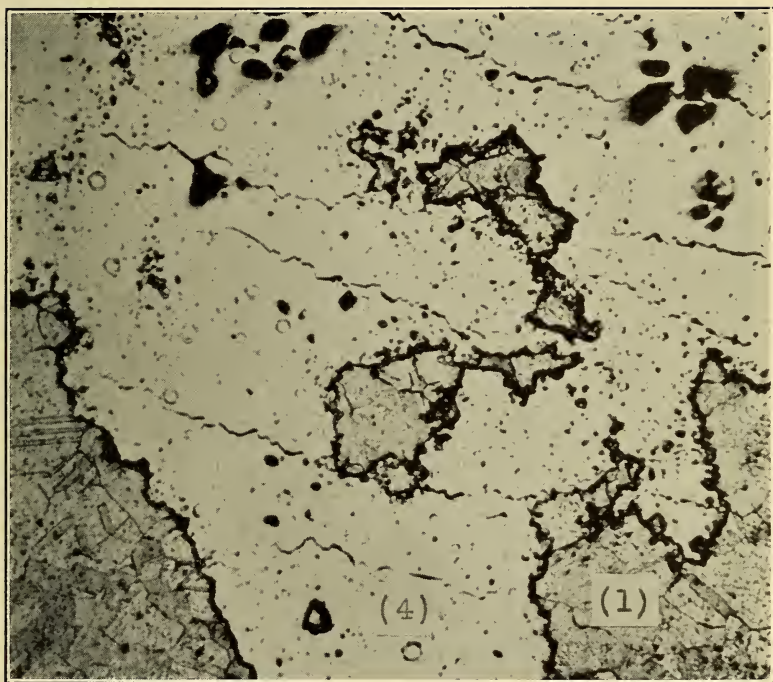
The characteristic microstructures of the soldered specimens are shown in Figures 11 to 13. Figure 12 shows the cracks in the very thick coating of copper-tin alloys on soldered and annealed copper. The black line between the copper and the alloys resulted from the deep etching of the copper, which is anodic to the coating in ammonium hydroxide.

FIGURE 12.—*Oblique section of sheet copper soldered at 270° C. and heated to 500° C. for 3 hours.  $\times 500$*

Etchant:  $\text{NH}_4\text{OH} + \text{H}_2\text{O}_2$ . 1, Sheet copper base; 4, copper-tin alloys.

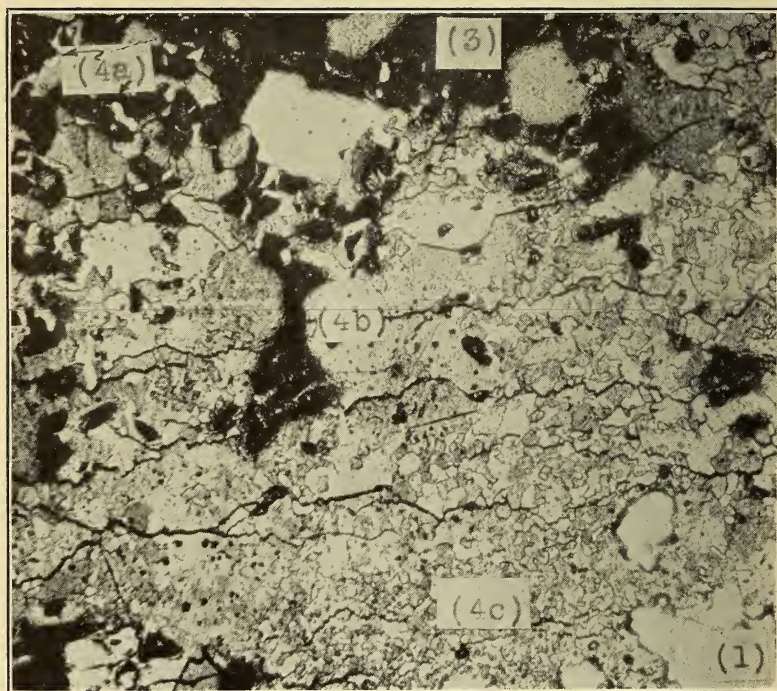
FIGURE 13.—*Same as Figure 12, but after prolonged etching with  $FeCl_3.HCl$  and nitric acid dip.  $\times 200$*

1, Sheet copper base; 3, unchanged solder; 4a, bright areas of  $\epsilon'$  phase; 4b,  $\eta$  phase; 4c,  $\delta$  phase.
